INDOOR AIR QUALITY ASSESSMENT

**South River Elementary School
54 Hatch Street
Marshfield, Massachusetts**

Prepared by:
Massachusetts Department of Public Health
Bureau of Environmental Health
Indoor Air Quality Program
March 2008

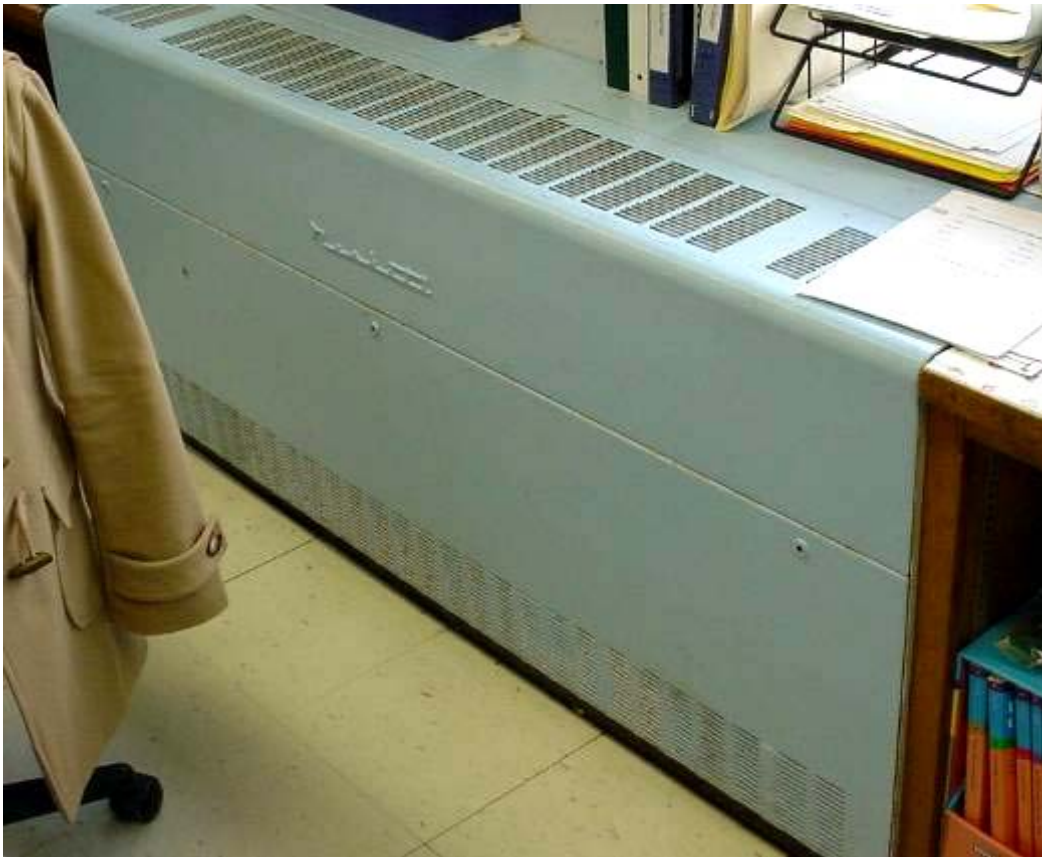
Picture 1

Fresh air in classrooms is supplied by unit ventilator (univent) systems (Picture 1). A univent draws air from outdoors through a fresh air intake located on the exterior wall of the building (Picture 2) and returns air through an air intake located at the base of the unit ([Figure 1](#)). Fresh and return air are mixed, filtered (Picture 3), heated and provided to classrooms through an air diffuser located in the top of the unit. In a number of classrooms, items were seen on and/or in front of univents obstructing airflow (Picture 4). Univents are reportedly original equipment from the 1950's. Univents of this age can be difficult to maintain because replacement parts are often unavailable.

Original 1950s Vintage Univent

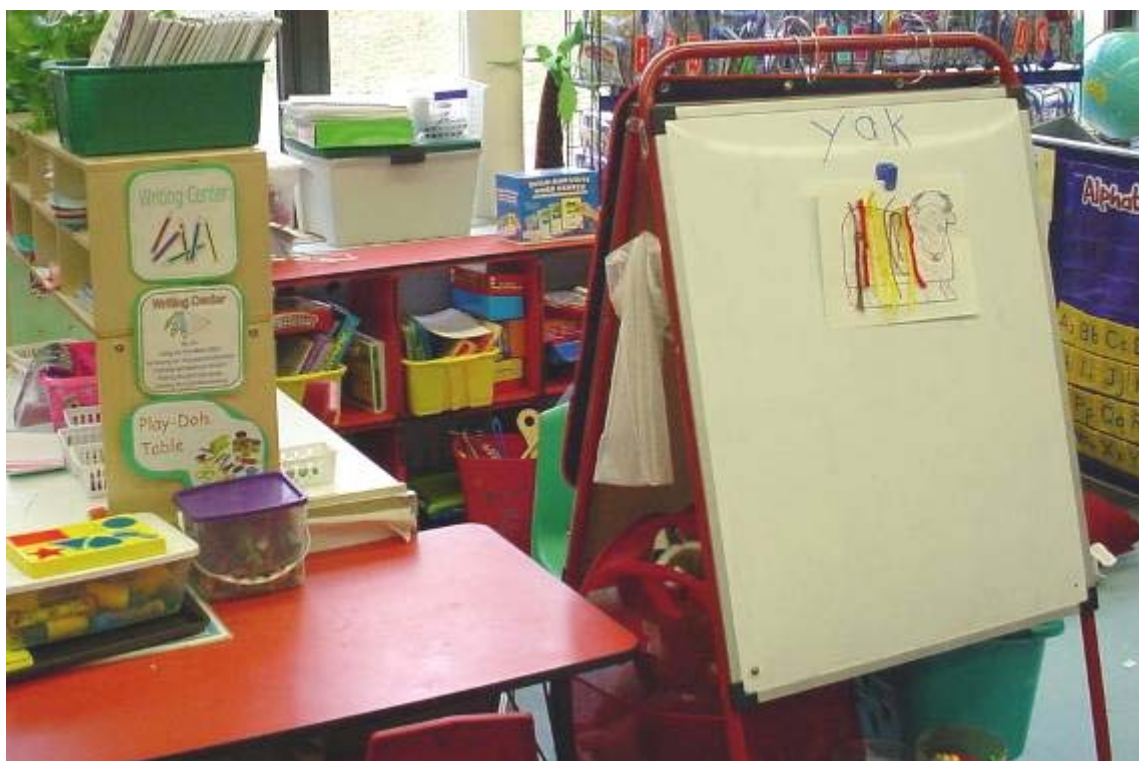
Picture 4

Classroom Furniture and Items Obstructing Univent (Exterior Wall) Airflow

3. Remove all blockages from univents and exhaust vents/cubbies to facilitate airflow.
4. Use openable windows in conjunction with classroom univents and exhaust vents to increase air exchange. Care should be taken to ensure windows are properly closed at night and weekends to avoid the freezing of pipes and potential flooding.

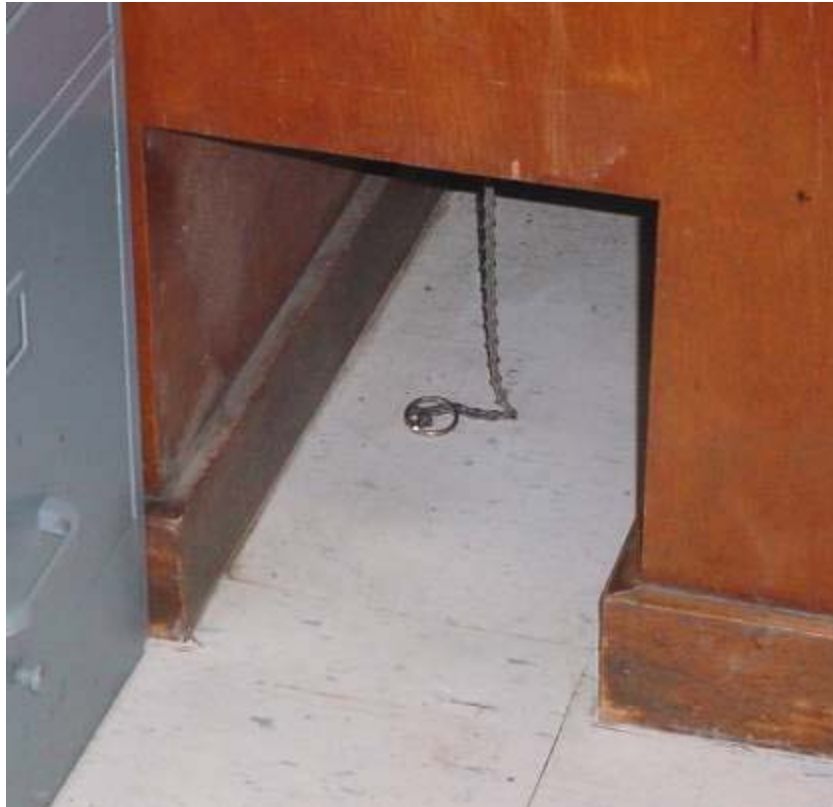
Picture 5

Exhaust vents in the 1950 portion of the building are located in floor level "cubbies" powered by a motor located in a cupola (Pictures 5 and 6). Exhaust vents for the 1952 addition are located on classroom walls (Picture 7). In both cases, the amount of airflow into the exhaust vent can be adjusted by a flue connected to a pull chain (Pictures 5 and 7). Additional exhaust vents in the 1952 classrooms are located in the ceilings of coat closets (Picture 8). Air is drawn into the coat closet from the classroom via undercut closet doors (Picture 9). Many of the exhaust vents were obstructed by various classroom items, limiting airflow (Pictures 10 and 11). In order for univents and exhaust vents to operate as designed, they must remain free of obstructions and be allowed to operate while rooms are occupied.

Exhaust Cubby with Pull Chain in Original 1950 Portion of Building

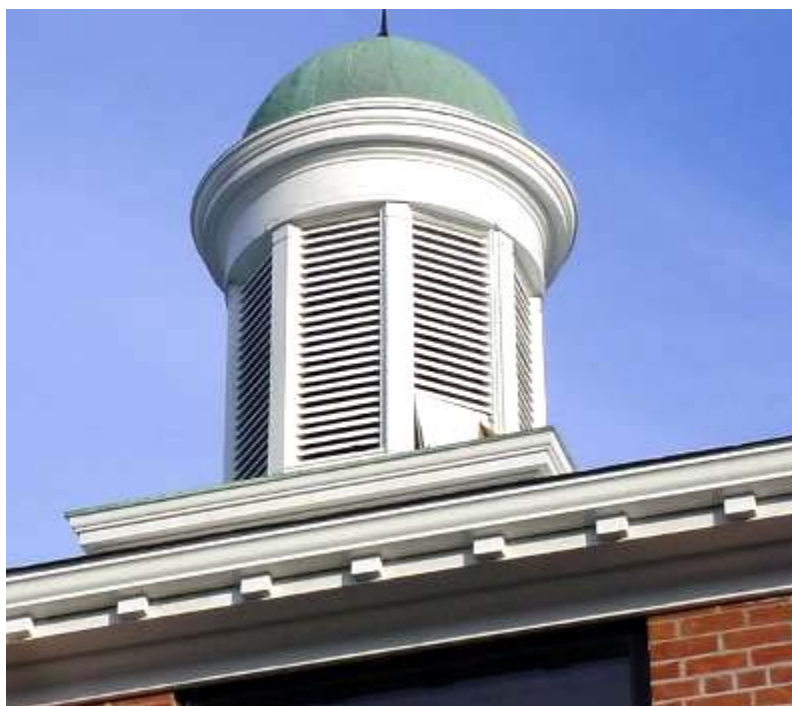
Picture 6

Cupola Containing Exhaust Motor for Exhaust Vents in Original 1950 Portion of the Building

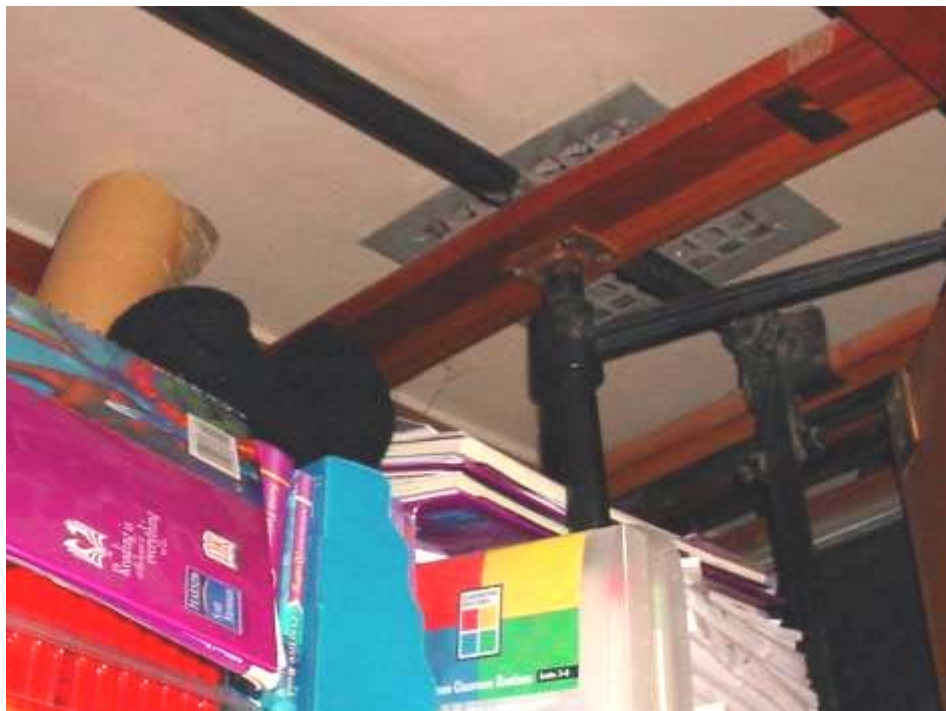
Picture 8

Exhaust Vent in Ceiling of Coat Closet, Note Stored Materials

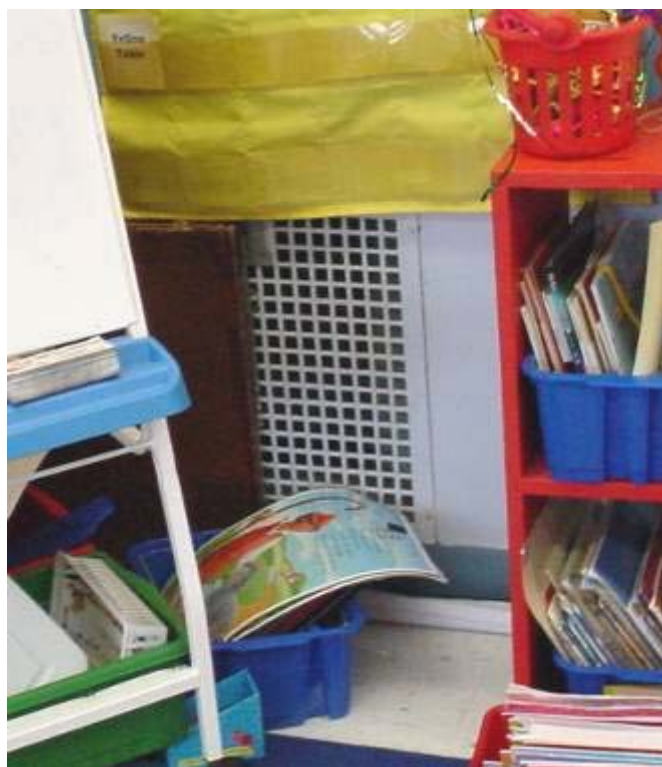
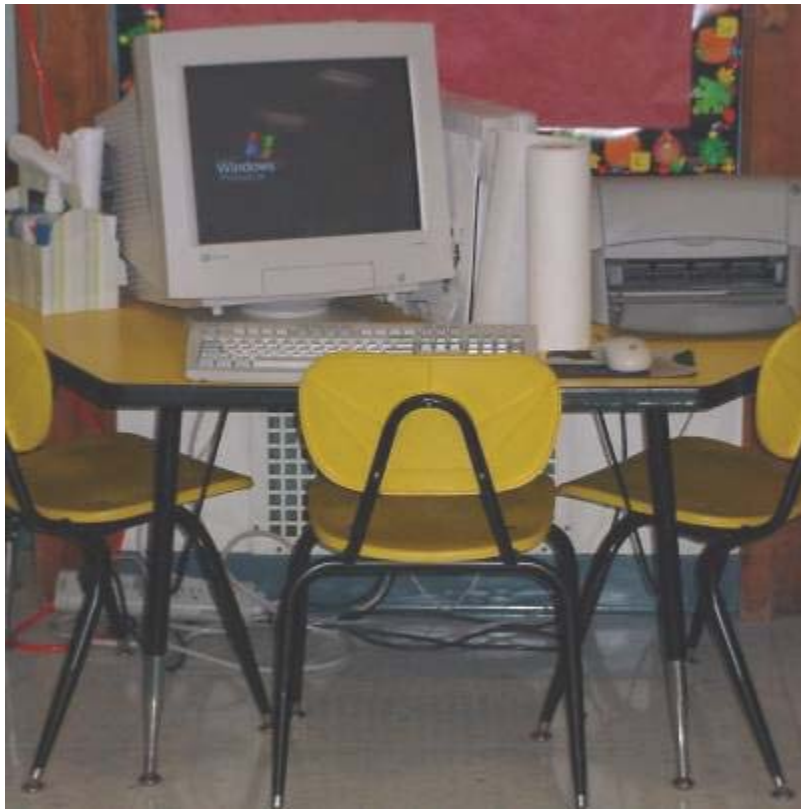
Partially Obstructed Exhaust Vent

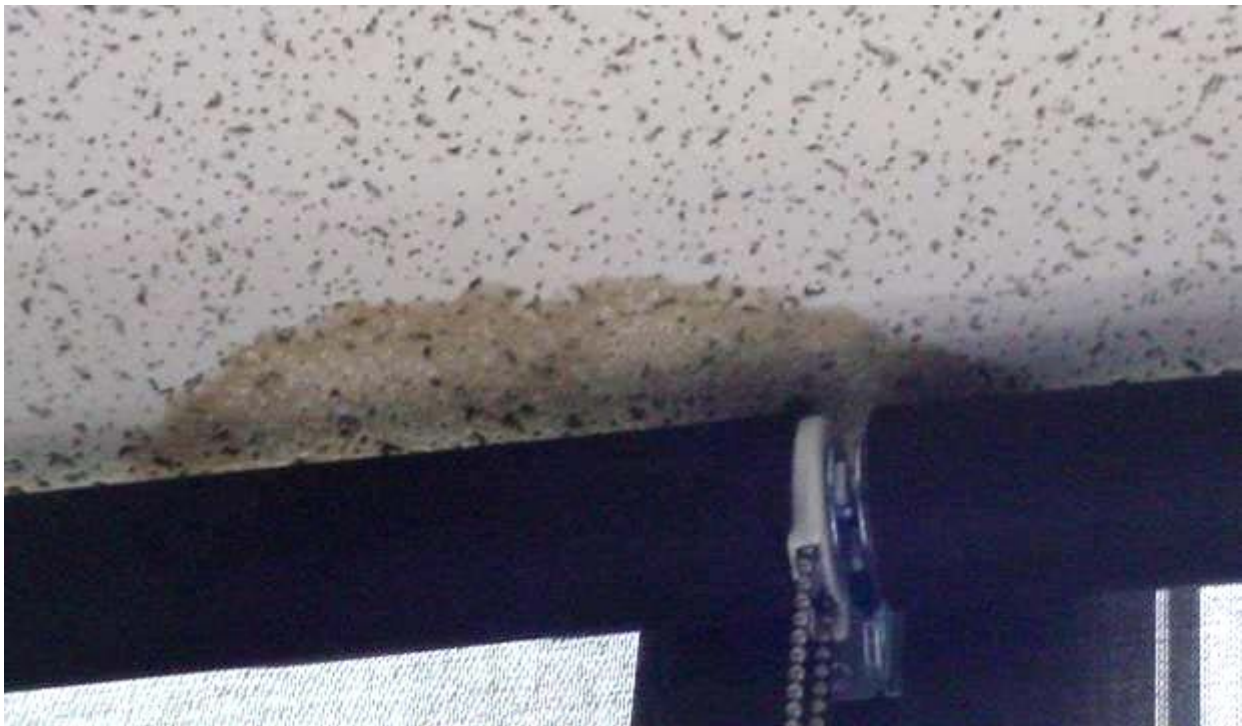
Picture 12

Several other areas of the building showed evidence of historical water damage and or had potential sources of moisture, which could lead to mold growth. Water stained ceiling tiles were seen in several areas (Picture 12/Table 1). Water-damaged ceiling tiles can provide a source for mold growth and should be replaced after a water leak is discovered and repaired. Active leaks were reported near windows in the computer room/stage area.

Water Damaged Ceiling Tile

9. Ensure leaks are repaired (e.g., computer room/stage area). Remove/replace water damaged ceiling tiles. Examine the areas above and around for mold growth. Disinfect areas of water leaks with an appropriate antimicrobial.

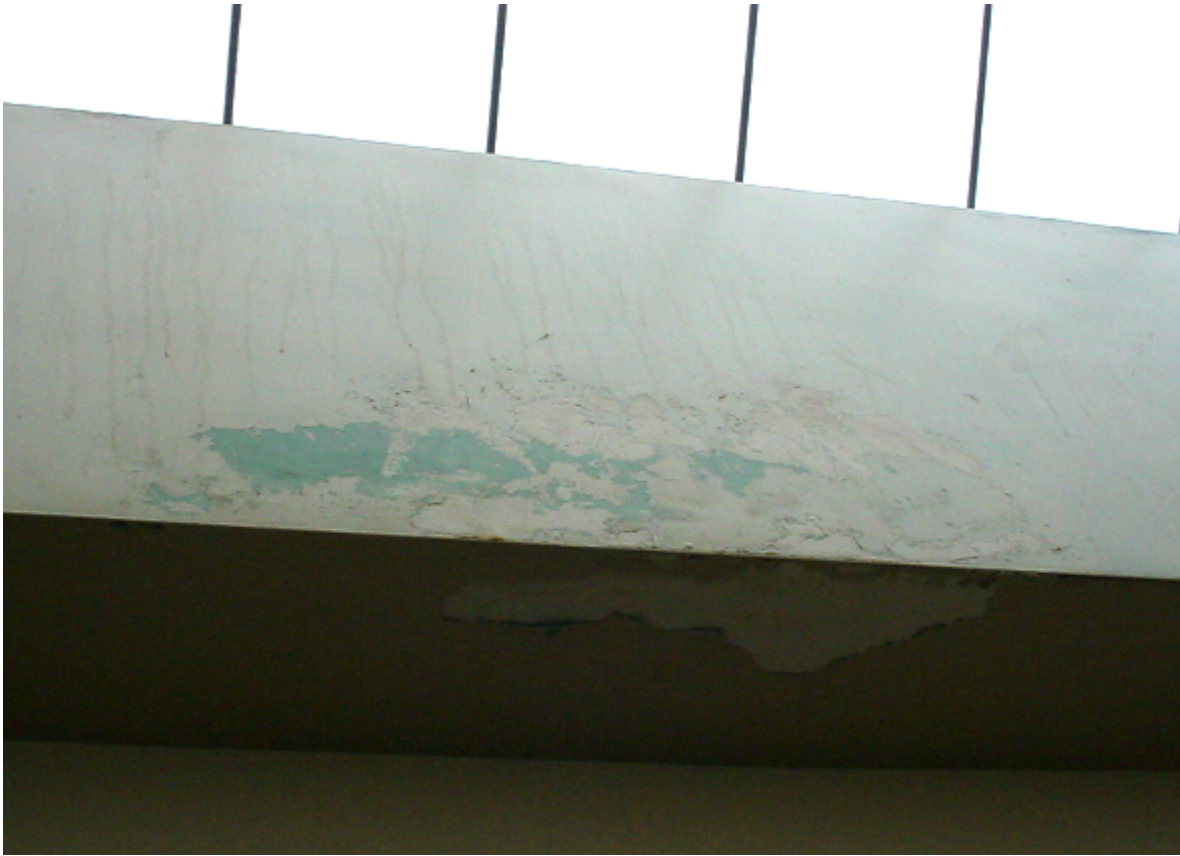
Picture 13

Water damaged ceiling plaster and peeling paint was observed in a number of areas including beneath a skylight in the boys restroom (Picture 13); in the teachers lounge, where the source of water penetration appeared to be through a passive attic vent directly on the exterior of the building (Picture 14); and in several exterior classrooms near windows, which appears to be historic damage prior to windows being replaced in 2002-2004. A consistent staining pattern was also observed in classroom 115 along the ceiling above pipes (Pictures 15 and 16). BEH staff conducted moisture testing to determine if the material was wet. Materials with increased moisture content *over normal* concentrations may indicate the possible presence of mold growth. The stained ceiling plaster tested during the assessment was found to have low (i.e., normal)

Water Damaged Wall/Ceiling Plaster in Boys Restroom under Skylight

10. Examine passive vent to attic (Picture 14) and skylight in boy's restroom; take measures to prevent water infiltration.
11. After leaks are repaired, make repairs to water damaged wall and ceiling plaster.

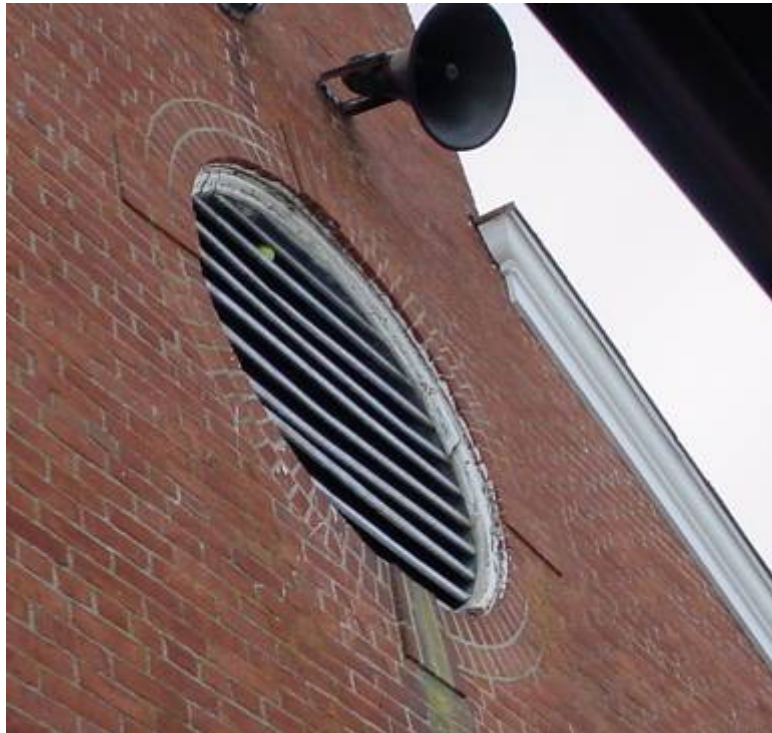
Picture 14

Exterior Passive Attic Vent Opposite Interior Water Damaged Ceiling Plaster in Teacher's Workroom

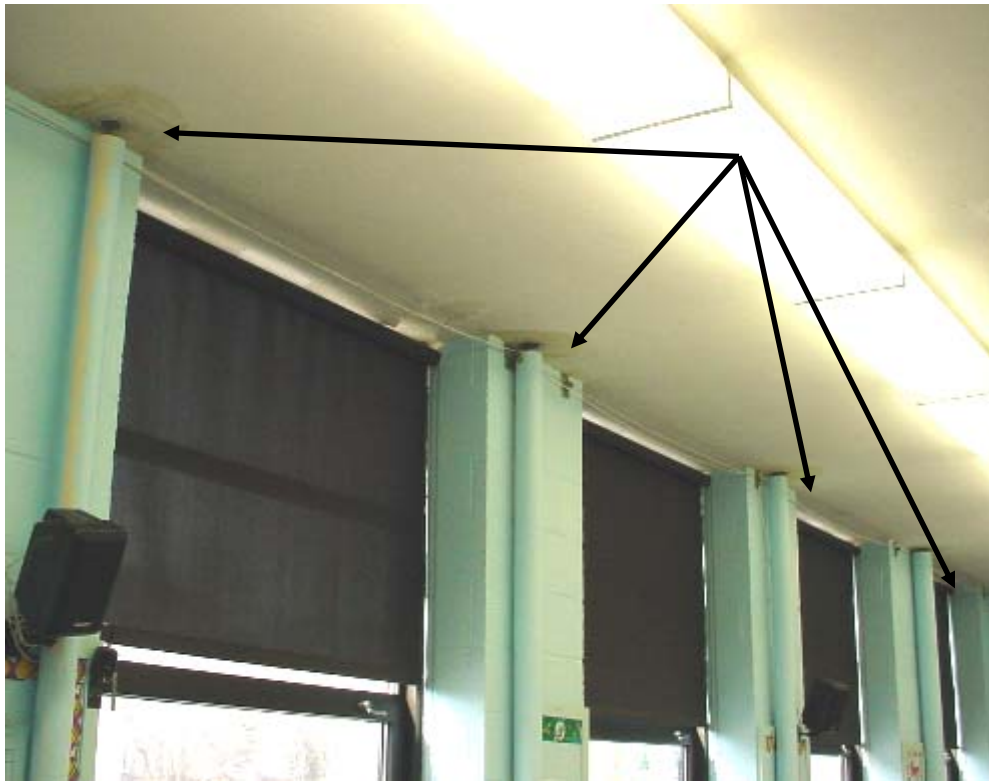
Picture 15

Patterned Staining of Ceiling Plaster near Pipes in Classroom 115

12. Contact a masonry firm or general contractor to repair holes/breaches in exterior walls to prevent water penetration, drafts and pest entry.
13. Move plants away from univents in classrooms. Avoid over-watering and examine drip pans periodically for mold growth. Disinfect with an appropriate antimicrobial where necessary.

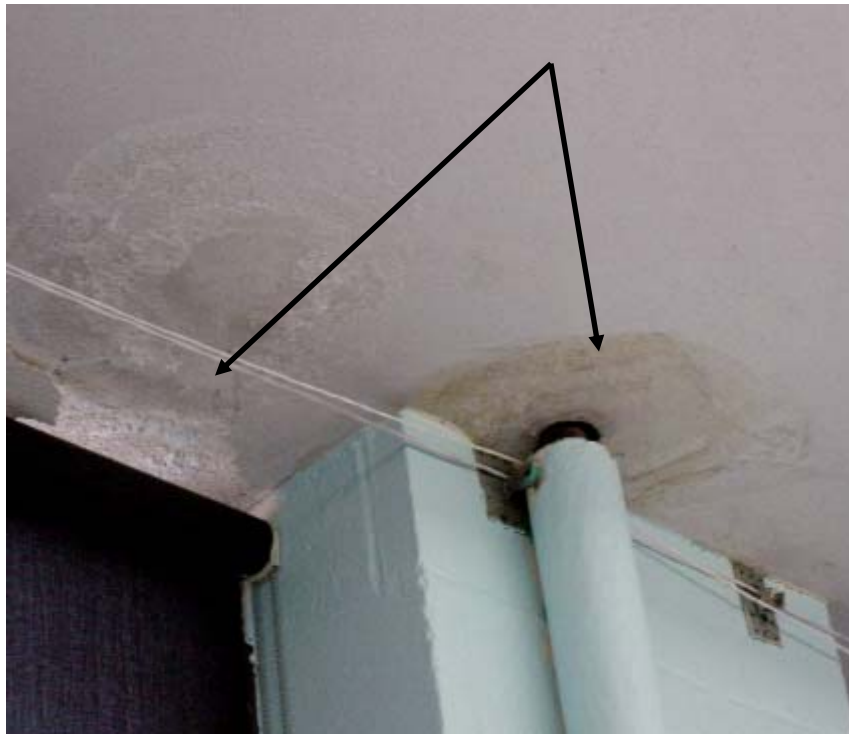
Picture 16

Close-Up of Water Damaged Plaster (Left) and Stained Plaster around Pipe (Right) Classroom 115

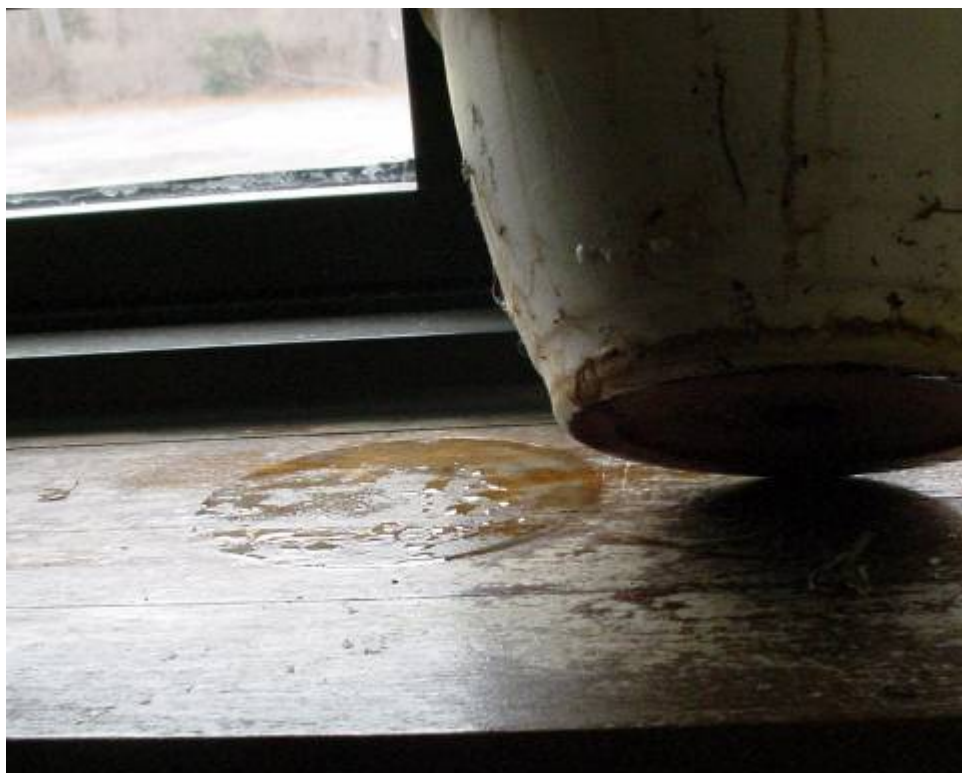
Picture 17

Several classrooms had a number of plants. Moistened plant soil and drip pans can be a source of mold growth. Plants should be equipped with drip pans; the lack of drip pans can lead to water pooling (Picture 17) and mold growth on windowsills. Plants are also a source of pollen. Plants should be located away from the air stream of ventilation sources to prevent the aerosolization of mold, pollen or particulate matter throughout the classroom. An indoor planter was observed in classroom 208. No source of drainage could be identified for this planter (Picture 18).

Moistened Wooden Windowsill beneath Plant in Stage Area

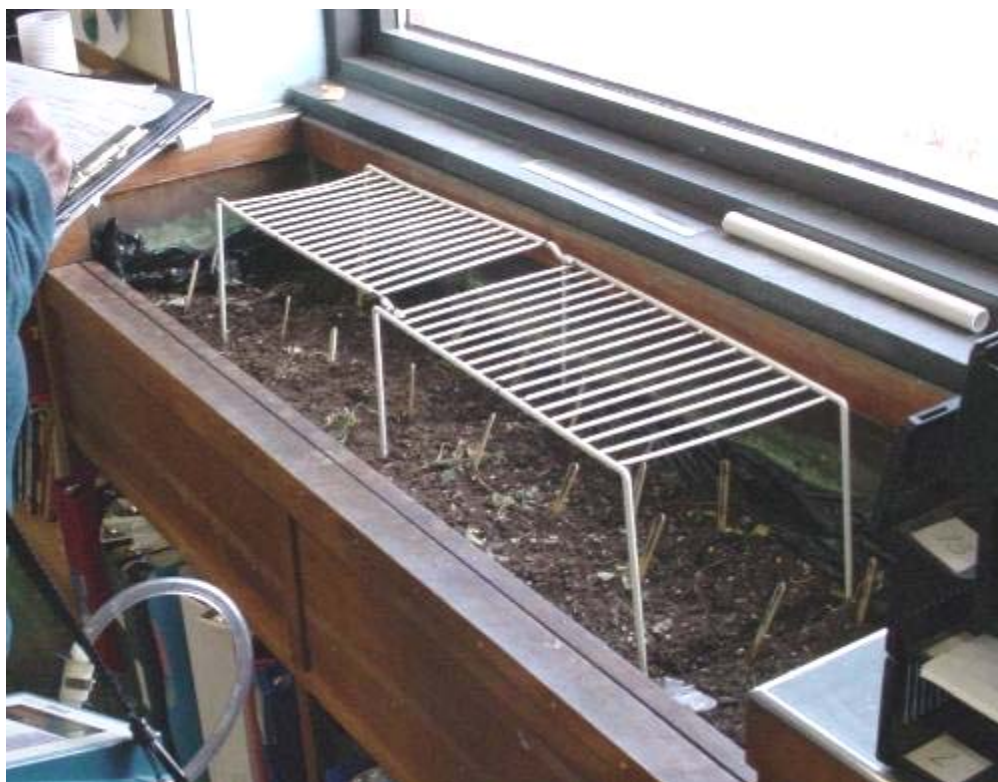
Picture 18

Indoor Planter in Classroom 208

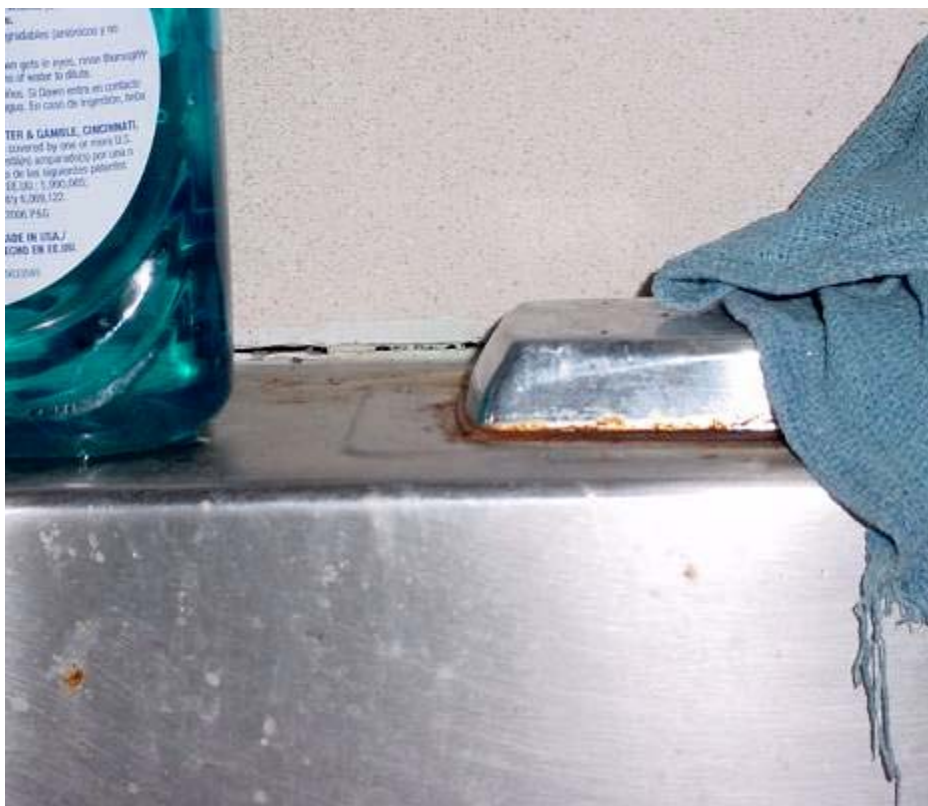
Picture 19

Open seams between sink countertops and walls were observed in several rooms (Picture 19/Table 1). If not watertight, water can penetrate through the seam, causing water damage. Improper drainage or sink overflow can lead to water penetration into the countertop, cabinet interior and areas behind cabinets. Water penetration and chronic exposure of porous and wood-based materials can cause these materials to swell and show signs of water damage. Many classrooms were also found to have porous materials (e.g., cardboard, paper, cloth) stored beneath sinks (Picture 20), which is a humid environment. Repeated moistening of porous materials can result in mold growth.

Spaces between Classroom Sink Countertop and Backsplash

14. Seal areas around sinks to prevent water-damage to the interior of cabinets and adjacent wallboard. Inspect wallboard for water damage and mold growth, repair/replace as necessary. Disinfect areas with an appropriate antimicrobial, as needed. Consider replacing with single piece molded countertops as shown in Picture 35.

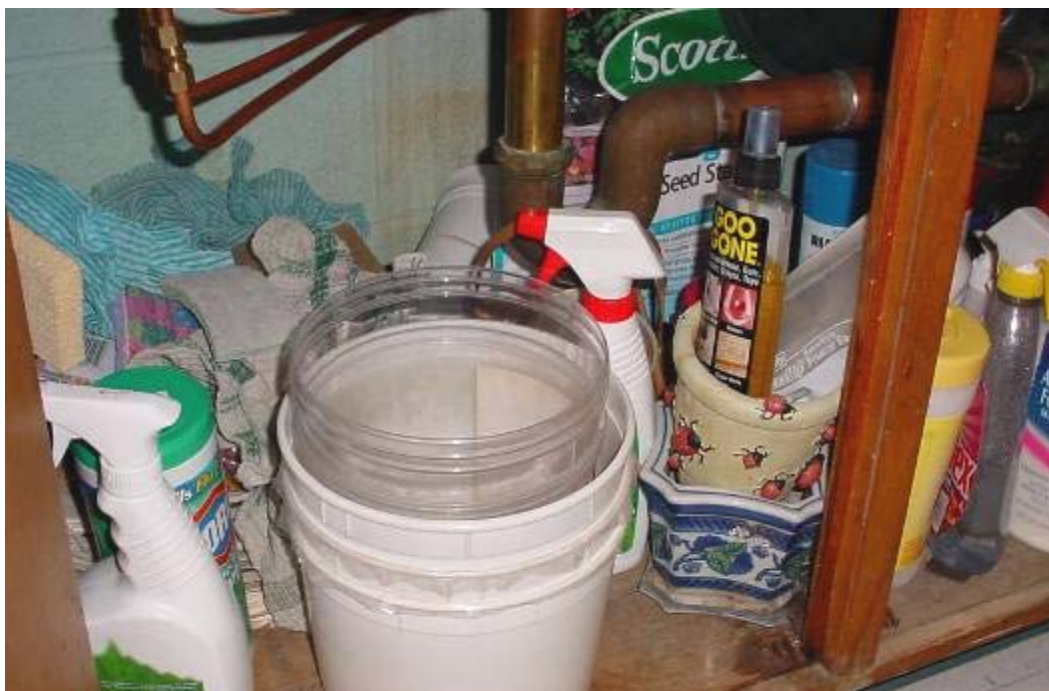
Picture 20

Please note, TVOC air measurements are only reflective of the indoor air concentrations present at the time of sampling. Indoor air concentrations can be greatly impacted by the use of TVOC containing products. In an effort to identify materials that can potentially increase indoor TVOC concentrations, BEH staff examined classrooms for products containing these respiratory irritants. Several classrooms contained dry erase boards and dry erase board markers. Materials such as dry erase markers and dry erase board cleaners may contain VOCs, such as methyl isobutyl ketone, n-butyl acetate and butyl-cellusolve (Sanford, 1999), which can be irritating to the eyes, nose and throat. Cleaning products were also found on countertops and in unlocked cabinets beneath sinks in some classrooms (Picture 20). Like dry erase materials, cleaning

Porous Materials, Cleaners and Spray Paint underneath Sink in Unlocked Cabinet

19. Store cleaning products properly and out of reach of students.
20. Clean upholstered furniture and pillows on the schedule recommended in this report. If not possible/practical, consider removal from classrooms.

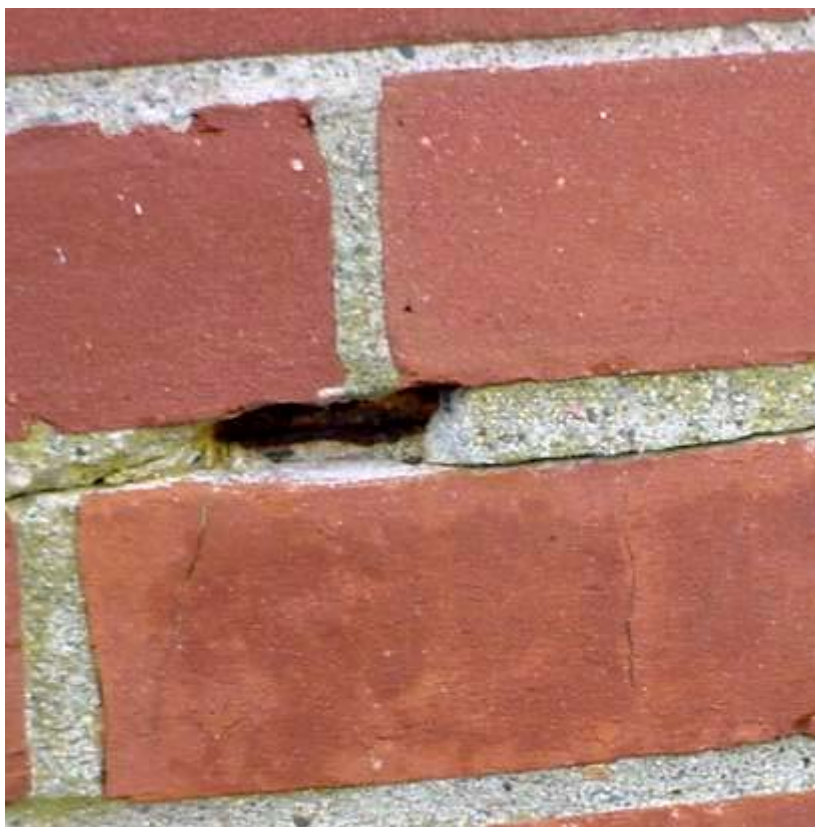
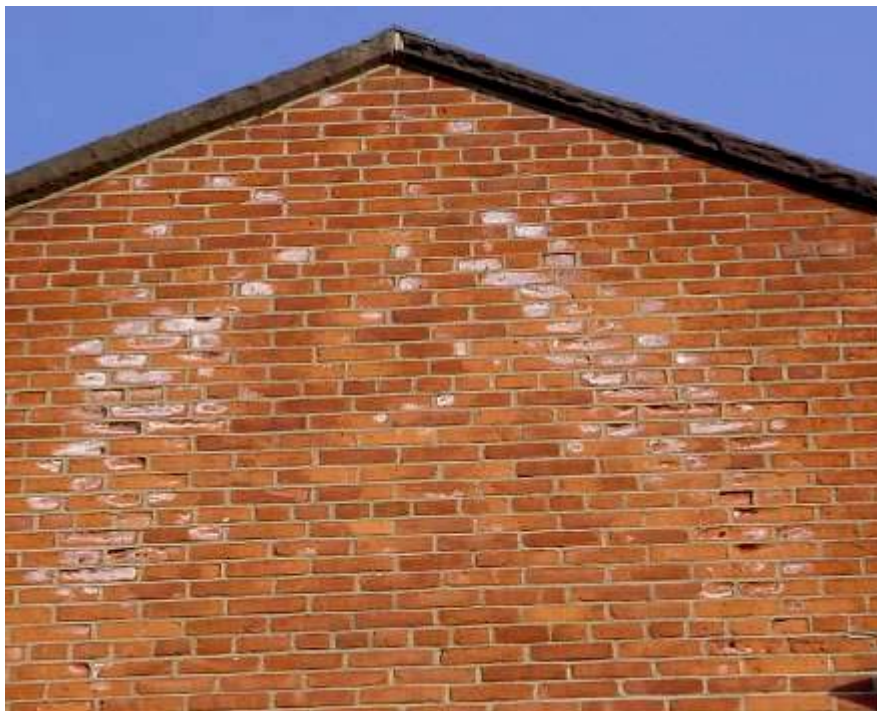
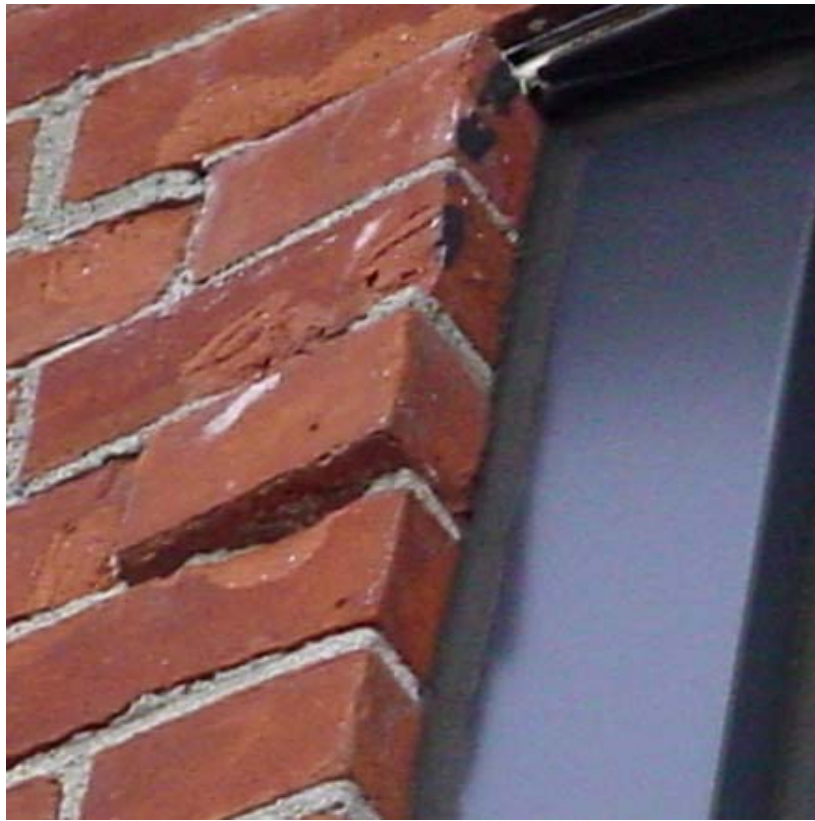
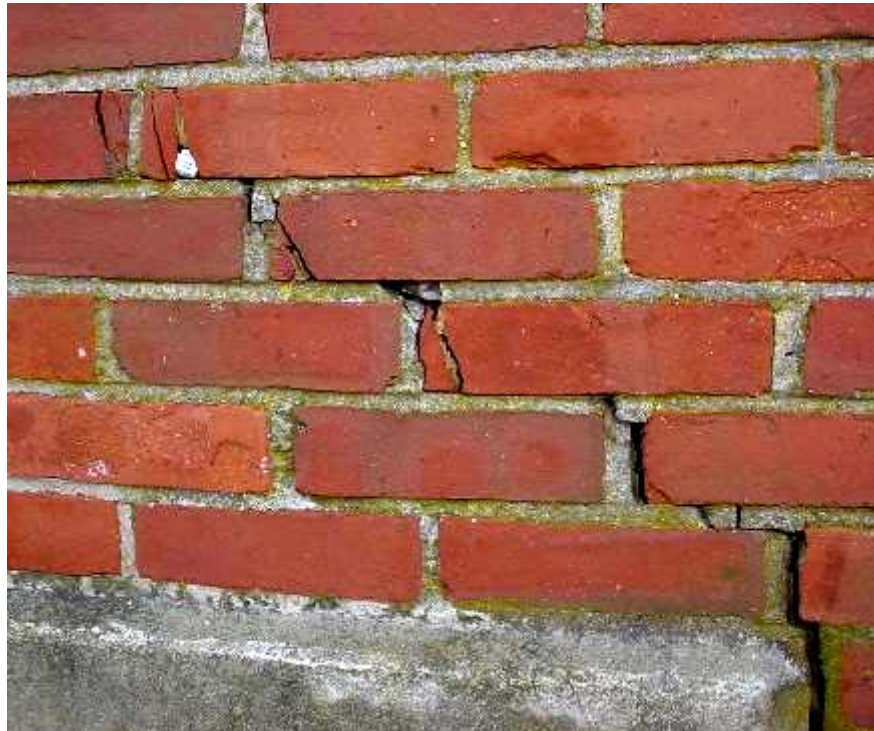
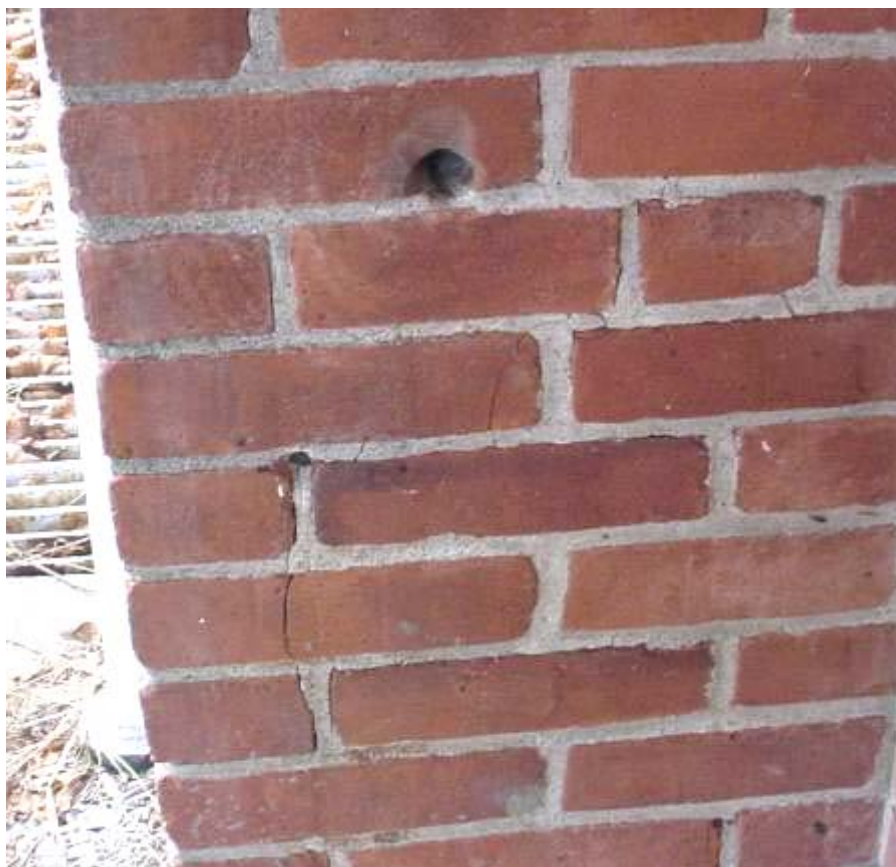
BEH staff examined the exterior of the building to identify breaches in the building envelope that could provide a source of water penetration. Several potential sources were identified such as damaged brickwork and missing/damaged mortar around masonry (Pictures 21 through 24) and open utility holes (Picture 25). These conditions can undermine the integrity of the building envelope and provide a means of water entry by capillary action into the building

Missing/Damaged Mortar around Brick

Missing/Damaged Mortar/Brick

Missing/Damaged Mortar around Brick along 2nd Floor Window Frame

Cracked/Damaged Exterior Brick along Rear of Building

Open Utility Hole and Cracked Brickwork

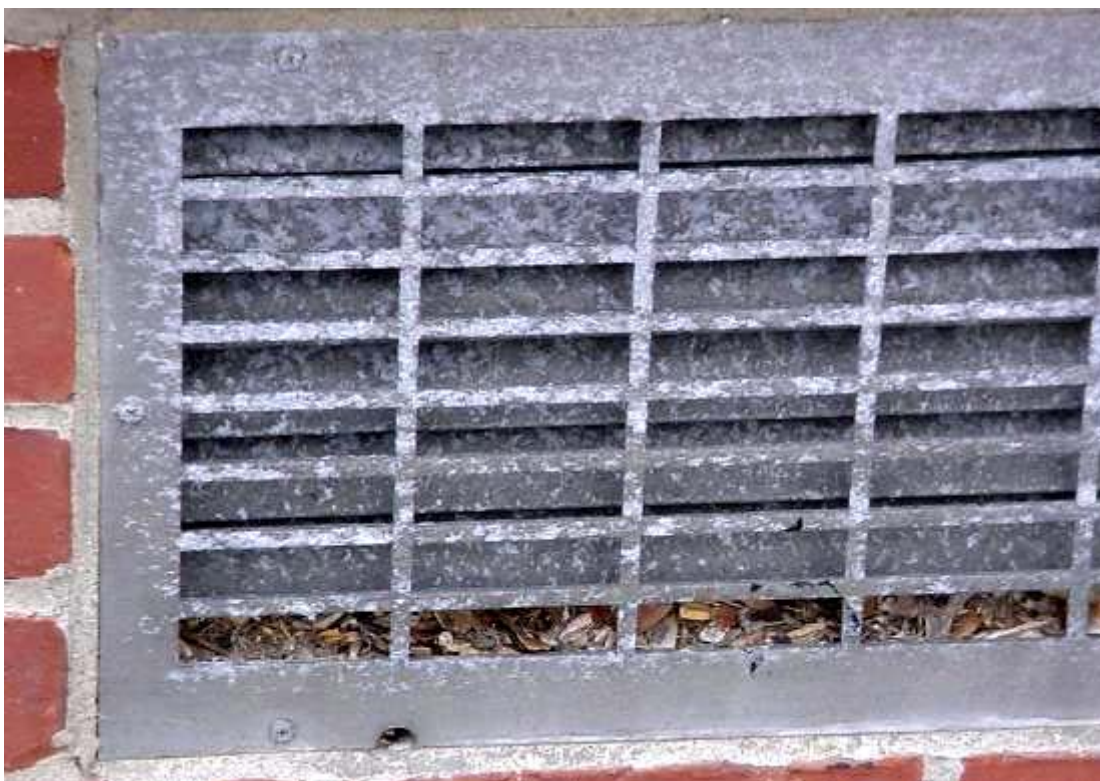
Picture 27

As reported by Principal Loiselle and Mr. Davis, black soot-like deposition was found on flat surfaces in classroom 109 in September 2006. Mr. Davis attributed the presence of the material to the start up of the boiler system; the material was cleaned and reportedly has not reoccurred. Although the start up of the boiler plant for the heating season may be the most likely source of the material, the configuration/location of the room may also contribute to accumulation of dirt, dust and debris. BEH staff examined the room and its relationship to the exterior of the building. This classroom is located at the terminus of an alcove where two wings intersect outside the building (Picture 26). Loose dirt and plant debris was observed below and had accumulated on the univent fresh air intake outside the building (Picture 27). BEH staff opened the univent cabinet to examine the interior and found similar accumulations of dirt and debris inside. It is likely that dirt dust/debris accumulates in this area due to the configuration of the outside of the building, an alcove that can trap air currents and stir up loose dirt/debris, which can then be drawn into the classroom via the univent.

Univent Fresh Air Intake, Note Debris in Bottom of Intake

17. Inspect exterior fresh air intakes for univents periodically, clean as needed. Particular attention should be paid in classroom 109.
18. Seal open utility holes in walls and ceilings to prevent migration of drafts and particulates into occupied areas.

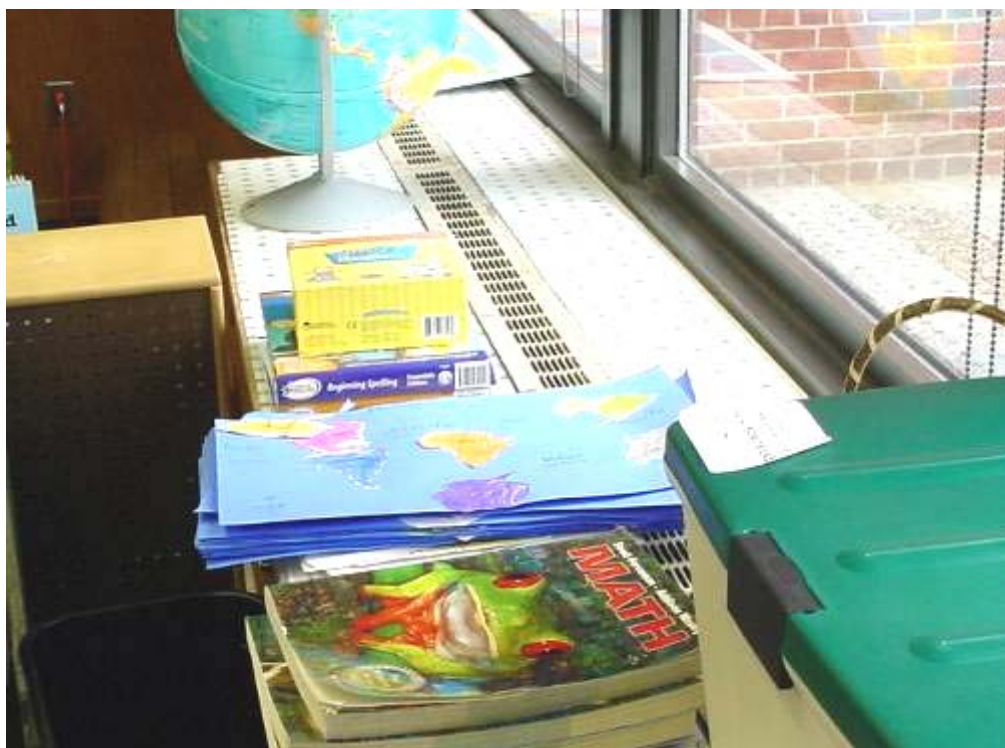
Picture 28

Another possible source relates to the radiator vents along the exterior wall/window system (Picture 28). During spring/summer common household dirt, dust and debris can settle into these vents. When the heating system is activated small particulates can become airborne as heat rises from the vents, providing a source of irritation.

Radiator Vents along Exterior Wall/Window of Classroom 109

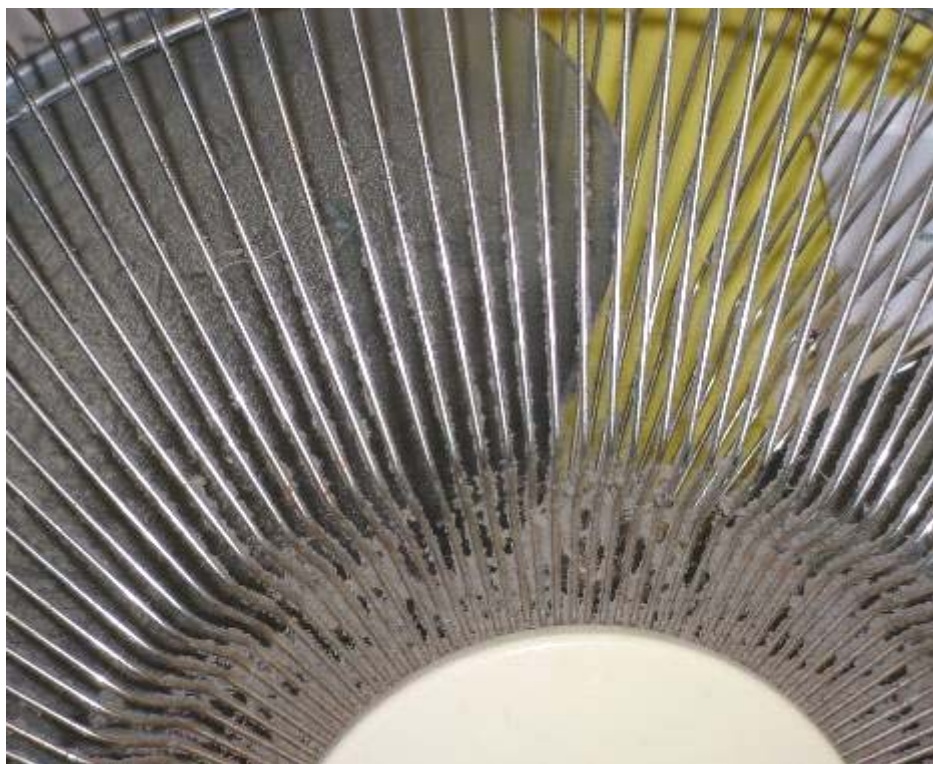
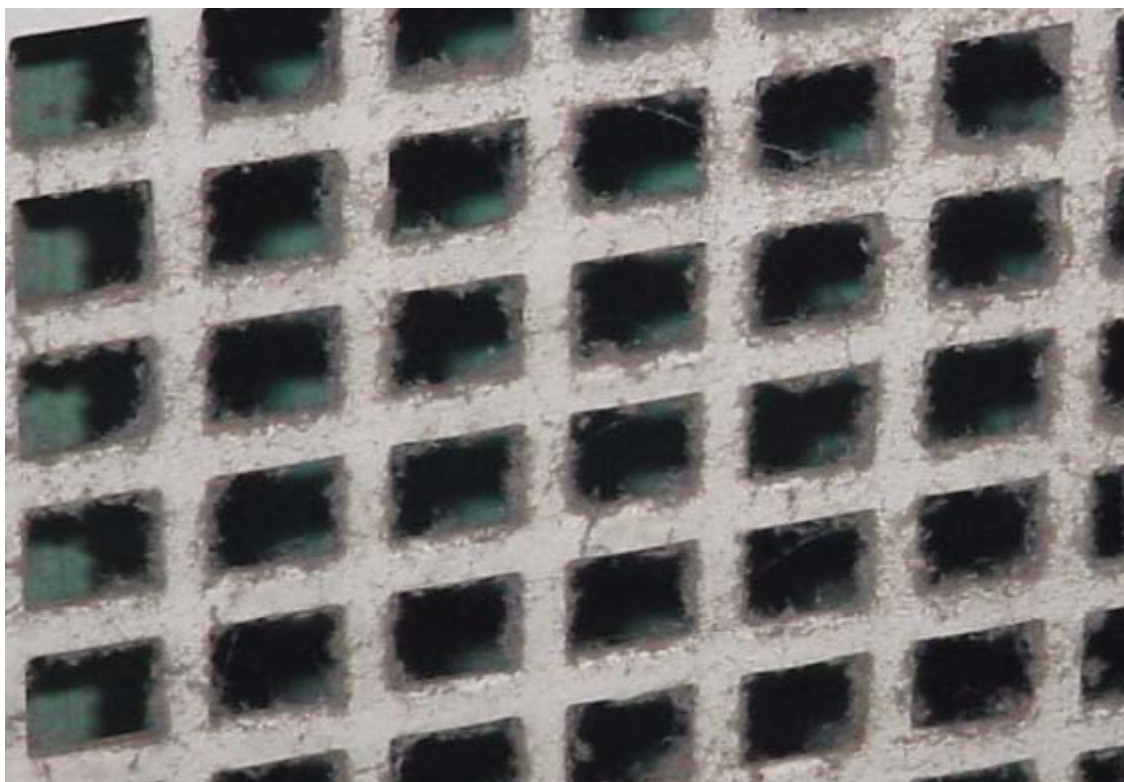
A number of personal fans and exhaust/return vents were observed to have accumulated dust (Pictures 29 and 30). If exhaust vents are not functioning, backdrafting can occur, which can re-aerosolize accumulated dust particles. Re-activated fans can also aerosolize dust accumulated on vents/fan blades. Open utility holes were observed in ceilings and walls in rooms 206 and 209, which can serve as pathways for drafts, dust and debris that accumulates in the ceiling plenum/wall spaces into occupied areas (Pictures 31 and 32).

Accumulated Dust/Debris on Classroom Fan

Accumulated Dust on Exhaust Grill

16. Clean personal fans, univent air diffusers, return vents and exhaust vents periodically of accumulated dust. Particular attention should be paid in classroom 109.

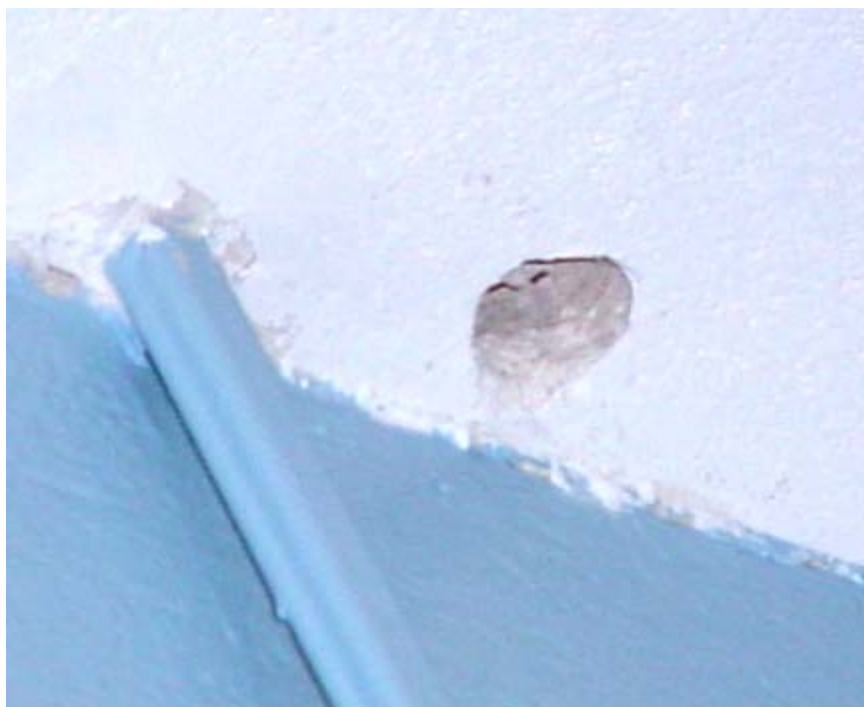
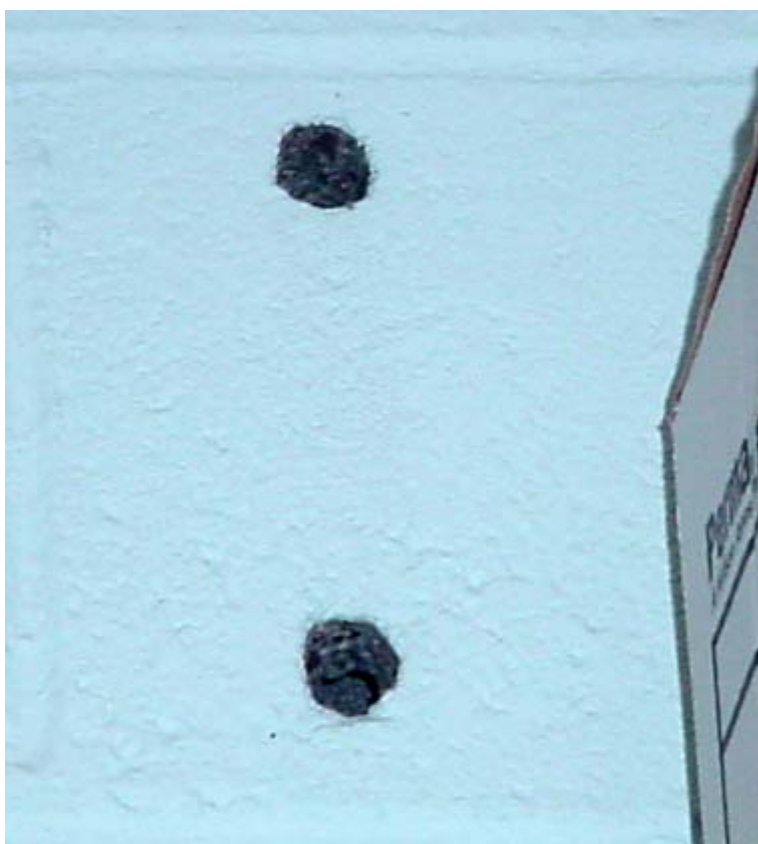
Open Utility Hole in Classroom Ceiling 206

Open Utility Holes in Classroom Wall
